## 2.0 The Master Plan

### 2.3.4 General Street and Subsurface Utility Improvements

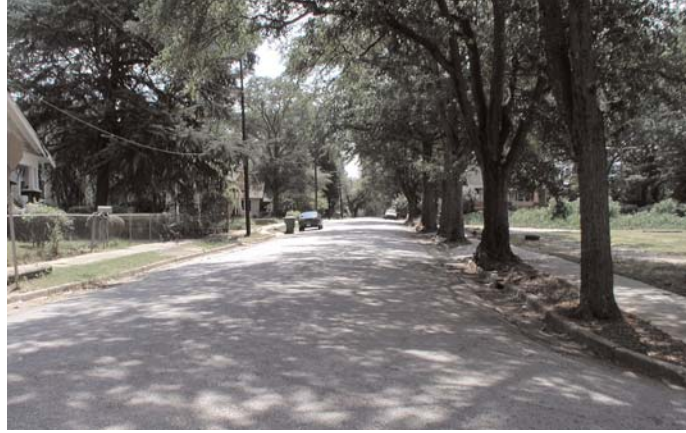
*Existing street conditions on Rose Avenue showing only minor needs for maintenance of curbs, sidewalks, and asphalt*

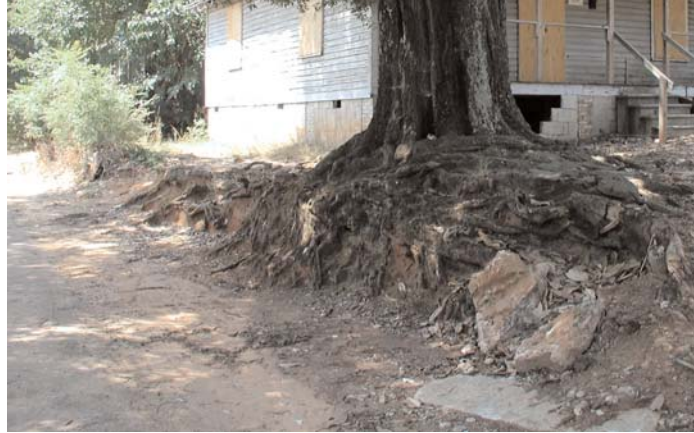
*Existing street conditions on Briar Street  
showing extensive deterioration*

- A comprehensive inventory of the pavement conditions for the area should be conducted immediately and prioritized using a standard engineering evaluation.
- Systematic resurfacing in this area should be accompanied by complete streetscape restoration and/or improvement.
- At a minimum, public improvements should include the complete reconstruction of the right-of-way to include standard pavement width and depth, curbs, landscaping, and sidewalks. Specifically, improvements to the following streets should be made as part of any public or non-profit investment in new housing:
  - ⌘ Chicora Avenue - 1,100 linear feet
  - ⌘ Dixon Street - 550 linear feet
  - ⌘ Unnamed Street (Dixon to Chicora) - 200 linear feet
  - ⌘ Urban Street - 475 linear feet
  - ⌘ Springer Street - 1,125 linear feet

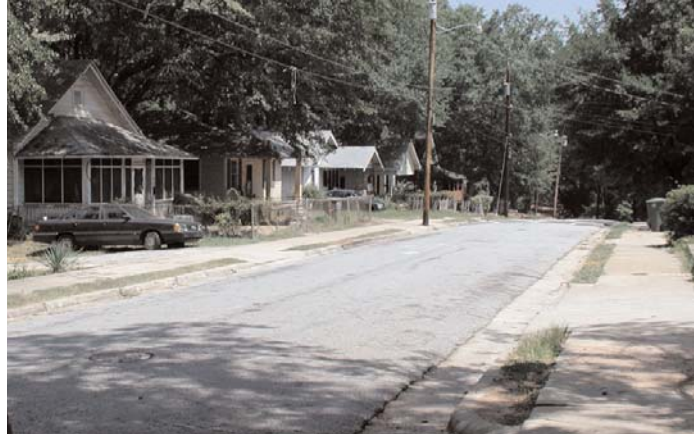
*Existing street conditions on Haynie Street showing existing cross section with curb, minimal planting strip, overhead utilities, and sidewalks*

- ⌘ Haynie Street realignment - 500 linear feet
- ⌘ Quincy Street extension - 400 linear feet
- ⌘ New E-W connection (Augusta to Urban) - 1,000 linear feet

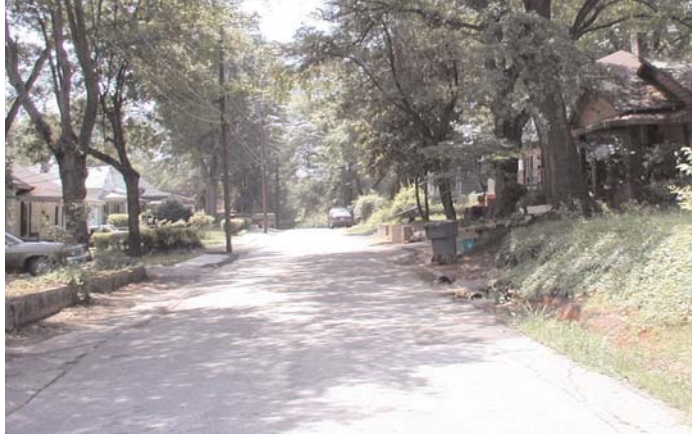
The only street in the entire study area that has been resurfaced recently is Chicora Avenue. Unfortunately, much of the drainage for that street remains in open ditches that are compromised by frequent driveway crossings and tree root overgrowth.

*Existing street conditions on Chicora Drive showing no curbs, sidewalks, and poor drainage conditions*

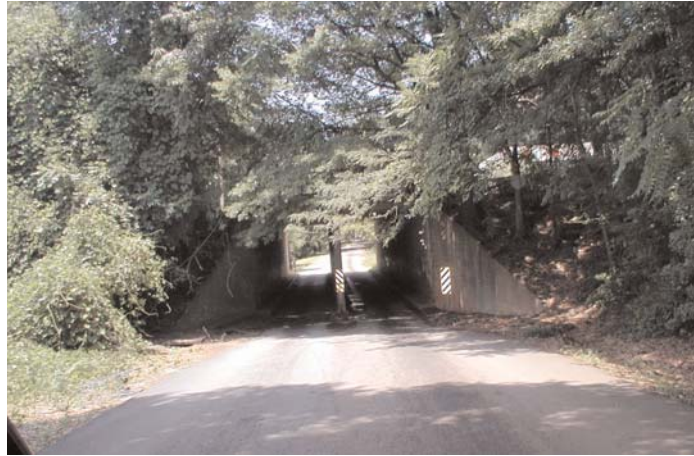
The only below-grade crossing of Church Street occurs at Springer Street. This tunnel is designed as a two way automobile passage with a full-height concrete wall separating the two lanes. The net effect of this design is the perception of two long, dark tunnels that are unsafe and hazardous to pedestrians whom we assume are the predominant users of the facility.

There is little lighting at either entrance and none exists within the tunnel itself, either through omission or vandalism.

*Existing Conditions at Springer Street Tunnel*

- Improve pedestrian and bicycle access through the tunnel by converting it to one-way (yield) traffic and dedicate the other for exclusive pedestrian and bicycle use. With so little automobile traffic through the tunnel and good visibility, such a change should have little impact on safety.
- Install and maintain new lighting to improve safety around the opening and inside the tunnel. Open a light well from the median in Church Street to permit natural light to enter the tunnel.
- Widen and improve the stairway up to Church Street to encourage more use and create a more monumental entry. Install a similar stairwell access on the other side of the tunnel to permit pedestrian access to the west side of Church Street.

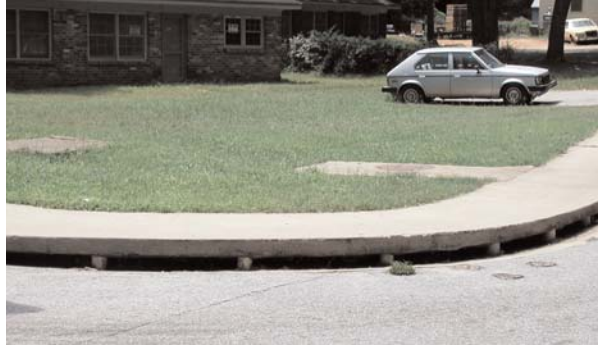
*Catch basins that are barriers to pedestrian movement*

Additionally, the stormwater structures, specifically, the catch basin inlets are barriers to pedestrian usage with some inviolation of the Americans with Disabilities Act because they preclude the installation of a curb ramp.

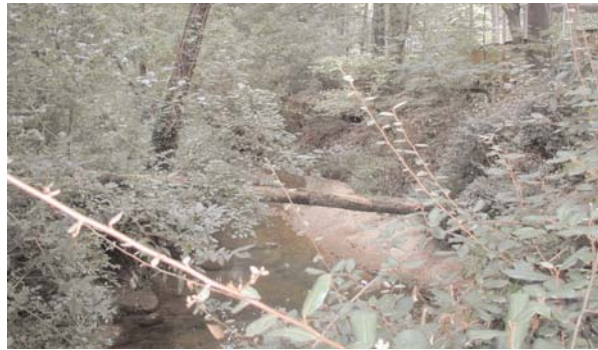
*Overgrown stream corridor*

The few stream corridors that exist in this area have been dramatically altered by past development encroachments and overgrowth by kudzu. In addition, the water quality has been degraded by excessive trash and debris found along its banks and in its channel. An existing creek has been piped in the proximity of Biltmore Drive and through the site of Sistine Stadium. This creek is daylighted on the north side of University Ridge. These creeks are part of the watershed that directly feeds the Reedy River just north of the study area.

- Institute a formal creek maintenance program to improve the overall condition of the streams in the neighborhood. Such a program will likely be part of the City's required implementation of Phase II of the Federal Clear Water Act NPDES Permit so its commencement for this area is appropriate.
- Commit to a public policy of daylighting streams whenever practical. Such a practice would improve the overall water quality for the area and will increase the capacity of the stream corridor through greater groundwater infiltration.
- Use open channel design as a sustainable, environmentally-friendly alternative for existing unmanaged streams
- Investigate the stream that is encased in a pipe along Biltmore Drive for potential daylighting.

- Clear the other primary creek present in this area, Springer Creek of the kudzu and overgrowth and repaire to a more natural condition. The restoration of this creek will not only improve its water quality, but it also will open up the area for improved saftey and general cleanliness. The probable springhead for this area, located near the bend in Springer Street, could serve as a Community Garden or other recreation area.

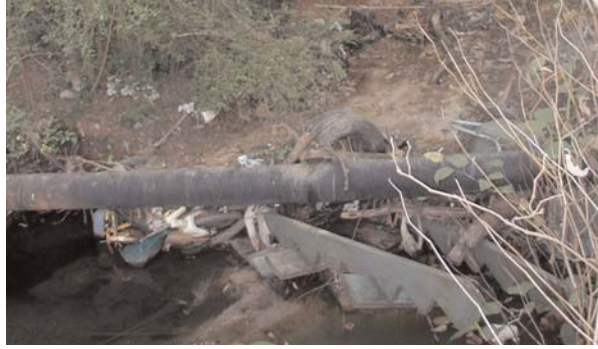
*Trash and exposed sewer line across stream*

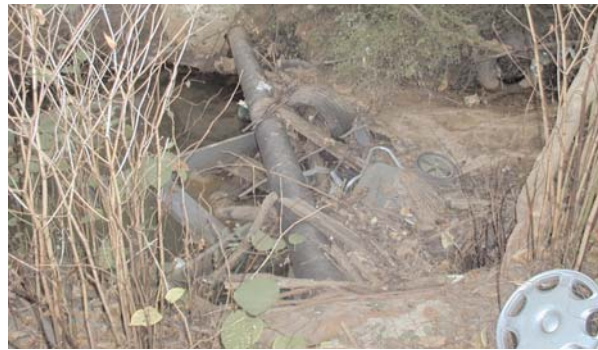
*More trash in the stream bed*
